NORWEGIAN HULL CLUB

Casualty Information

No. 109 - October 2020

**Fire risks due to the use of incorrect
air-filter and insulation materials**

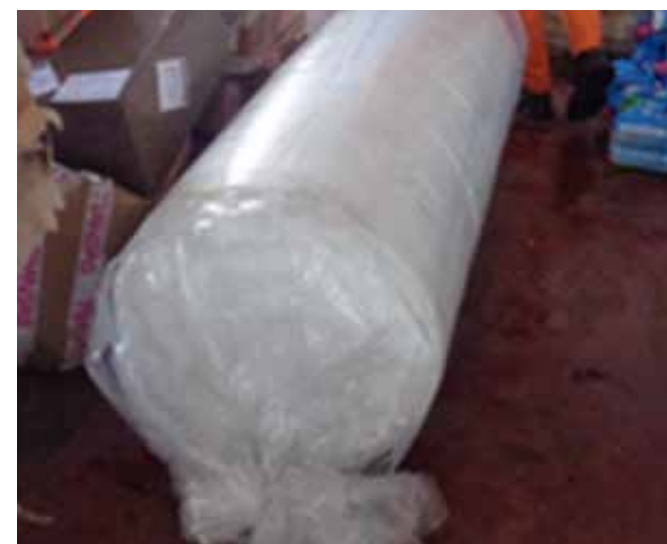
An example of polyester filter material

Polyester filter material is highly flammable and, when used in machinery located in the engine room, it will absorb oil / fuel vapors and hydrocarbon particles and become a potential source of ignition – essentially a torch ready to ignite.

Only filter materials specifically designed for diesel engines should be used. The correct filter material specification should also be included in a vessel's planned maintenance system / spare parts ordering system. This should prevent the crew using an incorrect type of filter by helping to ensure that they request the approved type.

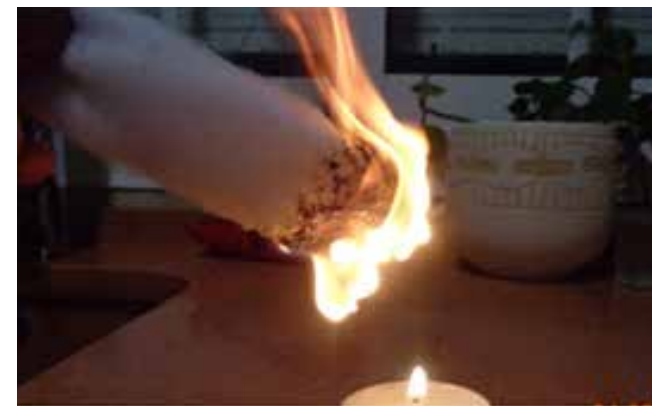
The polyester filter material is extremely flammable

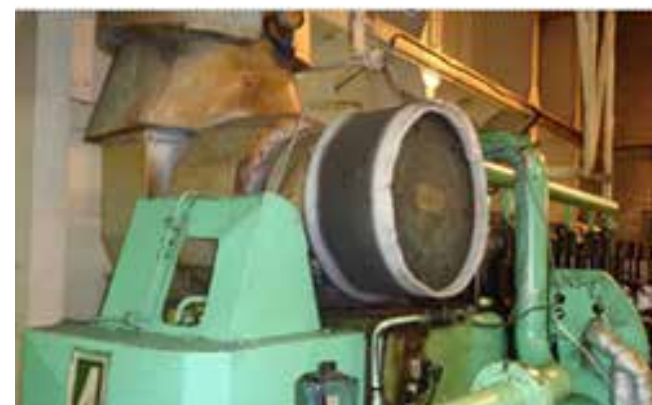
Such polyester filter material is frequently used, incorrectly, as a substitute air filter material on turbochargers

With regard to the use of polyester-type filters for turbochargers, in addition to the fire risk the filter mesh is very dense and creates air restrictions, thereby reducing air intake to the diesel engine which could have an adverse effect on engine performance.

With reference to SOLAS Chapter II-2 Part B – Prevention of Fire and Explosion Regulation 4 – Probability of Ignition, Norwegian Hull Club recommends that owners and managers initiate a risk assessment to reveal if flammable filter materials are being used on board as air filters for turbochargers and/or other machinery in the engine room.
