NORWEGIAN HULL CLUB

Casualty Information

No. 106 - June 2020

Overdue Maintenance of Engines and Equipment

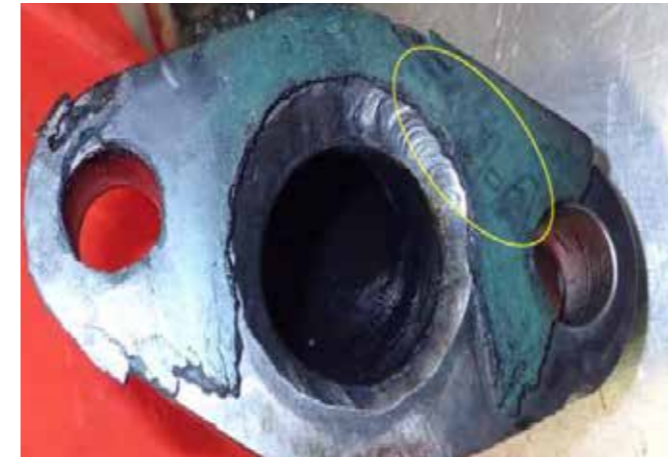
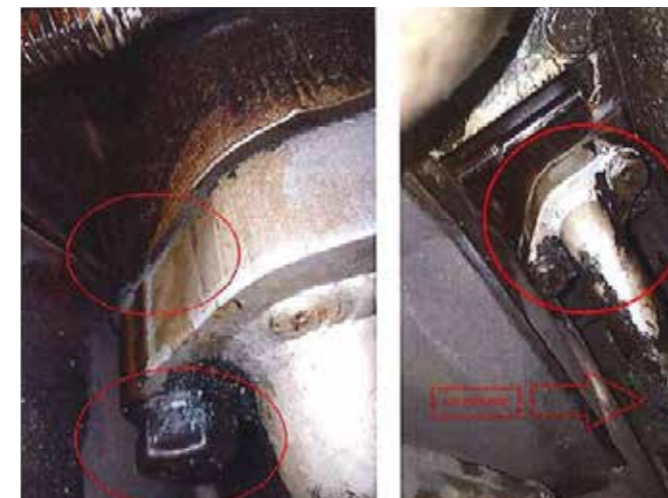
Example A

Incorrect type of sealing rings or packings may cause serious damage and even fire in the engine room, such as shown in the examples below.

Please check the specification of seals to ensure the correct type is used for the medium, pressure and temperature.

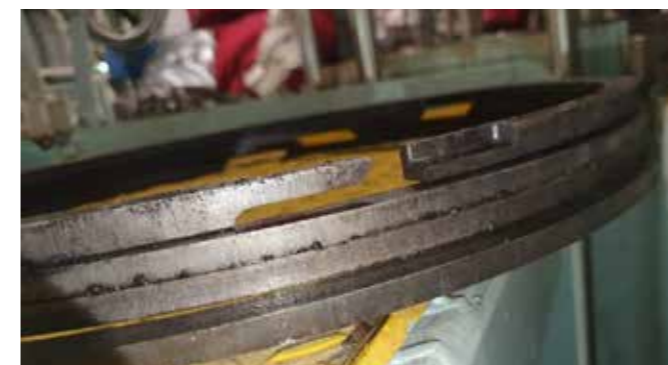
Example B

Incorrect type of piston ring is installed (for the fuel type in use) due to no spares being available. Piston rings are then worn out after short time in operation, resulting in a long off-hire period before the correct type of piston rings are received on board.
