## CASUALTY INFORMATION NO. 28 - DECEMBER 2001

### ENGINE CASUALTY DUE TO SUBSTANDARD MAINTENANCE WORK PERFORMANCE.

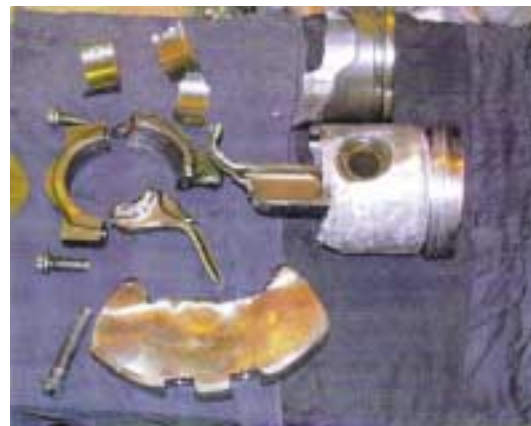
The connecting rods (CR) are of a three-piece design where the rod is bolted to the top of the big end bearing housing by four bolts (in the following these bolts will be called "palm bolts" (PB)), which are hydraulically tightened to 750 bar. The port main engine had been running for 16000 hrs, and it had just been through its first general overhaul, including Class inspection. The vessel's own crew carried out the overhaul of all cylinders, which included drawing all the pistons. Due to the three-piece design of the CR the pistons could be drawn without loosening the big end from the crank pin, but by loosening the easy accessible PB's instead. About 50 hours of operation after the overhaul, the port main engine sustained severe damages, as one piston seized in its liner while the CR, together with the lower part of the piston skirt fitted, was thrown out through the side of the entablature. Concurrently the engine fire alarm was set off, and the Chief Engineer activated the emergency shut-down procedure. During the subsequent inspection large cracks in the upper part of the entablature were found, and relatively large pieces had been torn off, and were shattered into small pieces. The piston was fractured about 300 mm below the lower piston ring and the remaining (upper) part of the piston was stuck in the liner. The lower part of the liner was fractured as well. Remnants of 3 PB's were lying at the bottom of the crankcase, while one bolt was found on the outside, together with the bent and deformed connecting rod. The mating face of the CR joint flange proved to be badly battered around the boltholes at one side. All the PB's seemed to have fractured near the mating face.

Three of the bottom end bearing bolts had fractured, while one was still in place, including the nut fitted; however, it was severely battered and bent. One of the counterweights of the damaged cylinder unit was lying at the bottom of the crankcase, badly battered and with fractured bolts, while the other was displaced, but still attached to the web. During subsequent inspection and checking of the PB's of several other cylinders, it was found that almost all the bolts became slack by pressures varying from 400 bar to 720 bar. These bolts should not have been slack until a hydraulic pressure of 770 bars had been reached.

No alarm for the port main engine was set off prior to the casualty, which was indicating normal running conditions (pressures and temperatures) for the engine. The result of the checking of the hydraulic opening pressure for the other PB's is clearly indicating that their nuts were probably not correctly tightened during the last engine overhaul. This caused one or more of the nuts to become loose during normal running conditions and subsequently they unscrewed themselves, with the consequential damages as described. One reason for the varying pressures found might be an incorrectly adjusted or calibrated hydraulic instrument. However, in this particular case this can be disregarded, because if that were the case the deviation in pressures should have been constant. One is therefore led to consider that the cause of the mishap is substandard work while tightening the nuts. Since no control of the work seems to have been done, the fault was not discovered.

- It is paramount that the people performing routine overhauls as well as repairs, adhere to the painstakingly worked out procedures that are in force.
- One must also spend the necessary effort needed to carry out sufficient quality control of the work done, for example work inspection or spot checks by experienced people who have not participated in the actual work (on board vessels this should be the chief engineer or the first engineer).
- Tools and instruments must be properly calibrated.

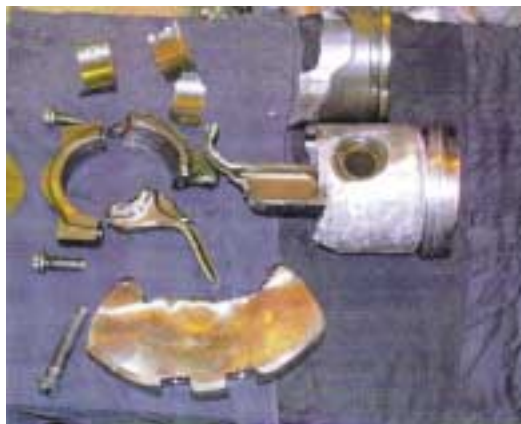
Veivstakene er tredelte, hvor staken er boltet til toppen av veivlagerhuset ved hjelp av fire bolter (som i det følgende kalles "veivstake - bolter" (VB)). Disse blir hydraulisk tiltrukket til 750 bar. Babord hovedmotor hadde en driftstid på ca 16000 timer totalt, og hadde nettopp gjennomgått sin første hovedoverhaling, samt klassing. Skipets egen besetning utførte overhalingen av alle sylindere, og dette inkluderte trekking av alle stemplene. Grunnet den tredelte konstruksjonen av veivstakene kunne stemplene trekkes uten å løsne veivstaken (VS) fra veivtappen, men i stedet løsne de lett tilgjengelige veivstakeboltene. Ca. 50 timers drift etter hovedoverhalingen fikk babord hovedmotor alvorlige skader, da et stempel skar seg i foringen, og veivstaken, sammen med den nedre del av stempelskjørtet ble slynget gjennom siden av sylindereblokken. Samtidig gikk brannalarmer i maskinrommet, og maskinsjefen gjennomførte nødprosedyre for nedstenging. Ved senere inspeksjon fant man store sprekker i den øvre del av sylindereblokken, og relativt store stykker hadde blitt slått av og var knust til små deler. Stemplet hadde delt seg omtrent 300 mm under nedre stempelring, og stempelets gjenværende (øvre) del satt fast i foringen. Den nedre del av foringen var også smadret. Rester av 3 veivstakebolter lå i bunnen av veivhuset, og en bolt ble funnet på utsiden, sammen med den bøyde og deformerte veivstaken. Kontaktflaten på veivstakens flens mot veivlagerhuset viste seg å være kraftig ramponert nær bolte-hullene på den ene siden. Alle VB'ene så ut til å ha blitt kuttet nær kontaktflaten. Tre av veivlagerboltene var også blitt kuttet, mens den siste fortsatt var på plass (inkludert mutter), men var alvorlig slått og bøyd.

En av kontravektene fra den skadede sylindereheten lå i bunnen av veivhuset, sterkt skadet og med avrevne bolter, mens den andre var forskjøvet, men fremdeles festet til veivskinken. I løpet av den etterfølgende inspeksjon og kontroll av veivstakeboltene på flere andre sylindere ble det funnet at nesten alle boltene løsnet ved trykk som varierte fra 400 til 720 bar. Disse boltene skulle ikke løsne før et hydraulisk trykk på 770 bar ble oppnådd.

Det gikk ingen alarmer før uhellet inntraff, noe som indikerer normal drift (trykk og temperaturer) for motoren. Resultatet fra sjekken av det hydrauliske åpningstrykket for de andre VB'ene indikerer klart at mutrene sannsynligvis ikke var blitt korrekt tiltrukket ved siste motoroverhaling. Dette forårsaket at en eller flere av mutrene løsnet ved normale driftsforhold, og skrudde seg deretter ut med de beskrevne følgeskader. En av grunnene til de varierende trykkene som ble funnet kan være feil justering eller kalibrering av det hydraulisk instrument. Imidlertid kan dette ses bort fra denne gangen, fordi hvis dette hadde vært tilfellet skulle trykkene ha vært konstante. Man ledes derfor til å anta at årsaken til uhellet er dårlig utført arbeid ved tiltrekking av mutrene. Siden det ikke synes å ha blitt foretatt kontroll av arbeidet, ble feilen ikke oppdaget.

- Det er overordentlig viktig at de som utfører rutineoverhaling og reparasjoner holder seg nøye til de nitidige utarbeidede prosedyrene som gjelder.
- Man må også spandere den nødvendige anstrengelse det er å utføre tilstrekkelig kvalitetskontroll av arbeidet, f.eks arbeidsinspeksjon eller tilfeldige kontroller (stikkprøver) ved erfarne folk som ikke har deltatt i selve arbeidet (om bord bør dette være maskinsjefen eller 1. maskinisten).
- Verktøy og instrumenter må være forskriftsmessig kalibrert.
