NORWEGIAN HULL CLUB

Casualty Information

No. 118 - January 2024

Vessel integrity - risk of flooding

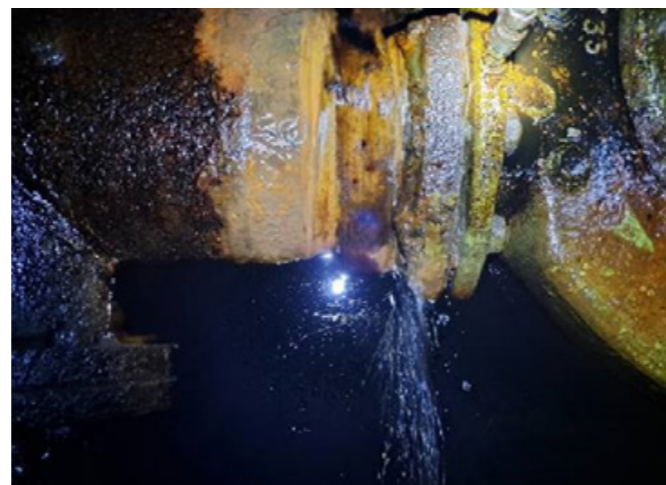
Leakage from seawater pump pipe flange welding due to corrosion

- Suction and overboard piping should be carefully inspected for corrosion before valves are reinstalled;
- Thickness measurements and pressure testing of pipe sections should also be considered;

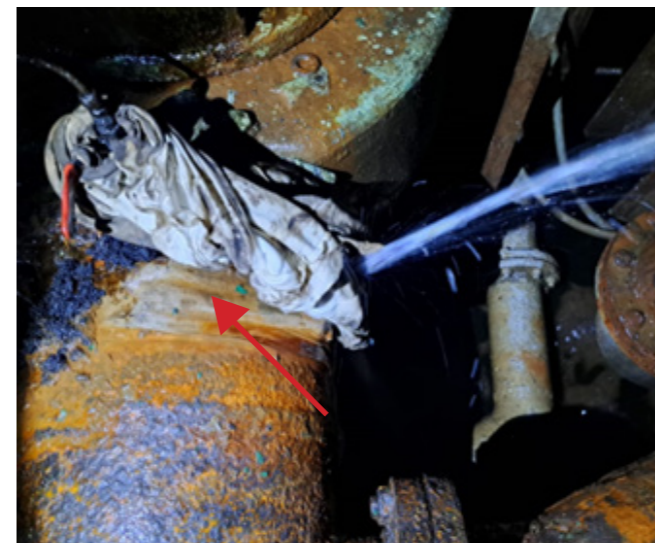
Ongoing repairs to pumps and valves had been performed by the crew for some time; however, due

Leakage from corroded pipe - previously 'repaired' by soft patching (red arrow)

to the lack of a permanent repair, the crew eventually lost control of the leakages.

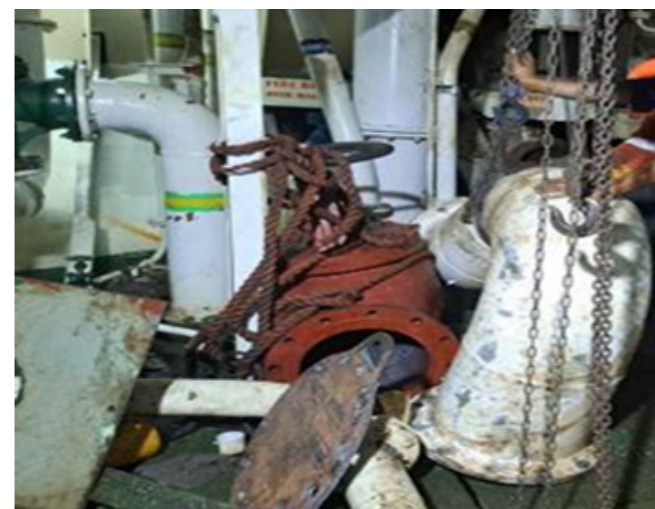
Corroded pipes, with seawater valves dismantled for repair / replacement

- 3) Seawater cooling and ballast pumps were found with leaking shaft seals, corroded and leaking pump covers and housings;
- 4) Seawater cooling and ballast water piping and flanges were leaking due to corrosion.

- Once the valves have been reinstalled, proper testing of their functionality and tightness should be conducted;
- For internal seawater and ballast pipes and isolation valves, the time during docking should be utilised to carry out inspections and any maintenance required. **Note:** If the overboard valves develop leaks during operation - e.g. due to marine growth, wear and tear or malfunction - the isolating valves are your secondary barrier.

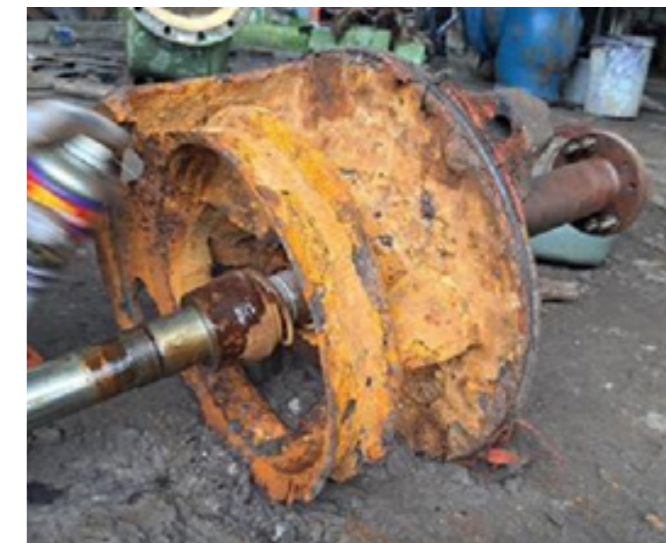
The pump cover and pump housing were found to be heavily corroded

- Pump housing, pump covers and shut-off valves should be carefully inspected during overhaul. Corroded pump parts, gate valves and butterfly valves will require overhauling or replacement.
