NORWEGIAN HULL CLUB

CASUALTY INFORMATION NO. 43 - MAY 2004

THE PIPE CRACKS.

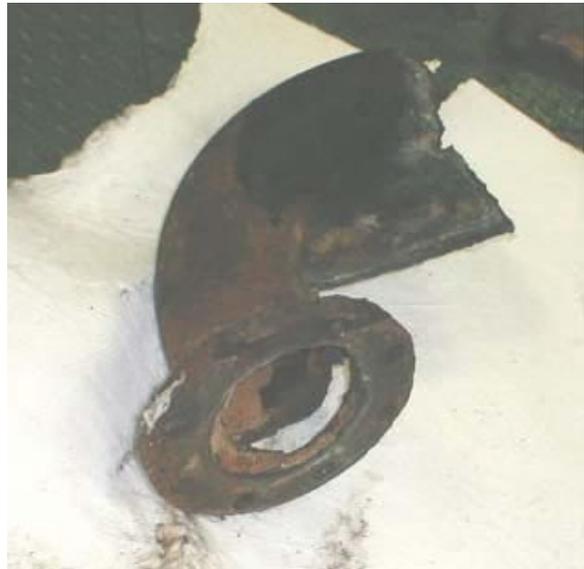
Upon arrival port the damage was more thoroughly investigated, and it became obvious that the crack appeared in a flange midway between the sea water chest and the valve. As the nature of the damage did not allow the water to be sealed off, the situation could have turned critical if the corrosion had been even more severe and if the ship had been on a trans-ocean voyage rather than in a coastal tramp traffic.

But the pipe section in question was somewhat hidden, and the program of both external and internal inspections and maintenance programs did not reach beyond the limits of the valve. Both the class society and own crew, including ship owner's inspectors, missed out the pipe system, hence allowing the pipes to corrode and virtually brake in two at the flange.

- Be aware to carefully inspect the parts of a system that may have the potential to cause any safety implications to the ship. A pipe mounted between the sea water chest and the sea water valve is obviously within this category.
- Don't trust that the class society always will discover any discrepancy onboard a ship during an inspection. Motivate your own crew to take responsibility, to be critical and encourage the crew to take action when required.
- Implement a «What if.. (worst case)» attitude as one of your main building blocks in the preventive apprentice-ship training.

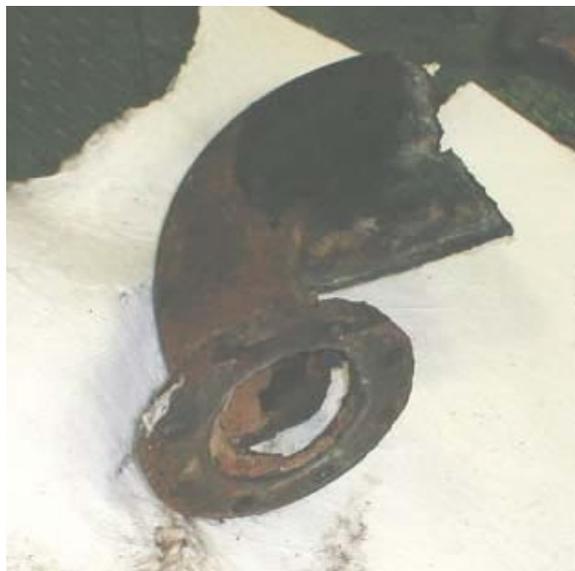
Ved ankomst havn ble skaden nærmere undersøkt, og det viste seg at røret var korrodert og lekket like bak sjøvannskisten, men foran sjøvannsventilen slik at vannet ikke kunne stenges av. Dette medførte at situasjonen ville utviklet seg kritisk om korroderingen hadde vært mer omfattende, og om fartøyet hadde befunnet seg lengre av land.

Men, fordi denne seksjonen av røret lå mellom sjøvannsventilen og sjøvannskisten, hadde seksjonen ikke vært gjenstand for hverken intern inspeksjon fra skipets side eller ekstern inspeksjon av klassifiserings-selskapet. Inspeksjonen av denne delen av systemet var rett og slett oversett av alle parter, noe som medførte at røret over tid fikk anledning til å korrodere, og til slutt måtte gi etter i en rørfless.

- Vær særlig oppmerksom på å inspisere de delene av et system som er kritiske med tanke på fartøyets sikkerhet. Et rør eller en rørstuss mellom sjøvannsinntaket og sjøvannsventilen er et slikt typisk kritisk område.
- Ikke stol på at klassen alltid vil finne mangler og kritiske bemerkninger til det enkelte skip. Oppfordre egen besetning til alltid å være årvåke og å heller kontrollere en gang for mye enn en gang for lite.
- Innfør en «hva hvis.. (worst case)» holdning som en av grunnstenene i det forebyggende opplæringsarbeidet ombord.
