NORWEGIAN HULL CLUB

Casualty Information

No. 108 - October 2020

Preventing fires in a vessel's laundry

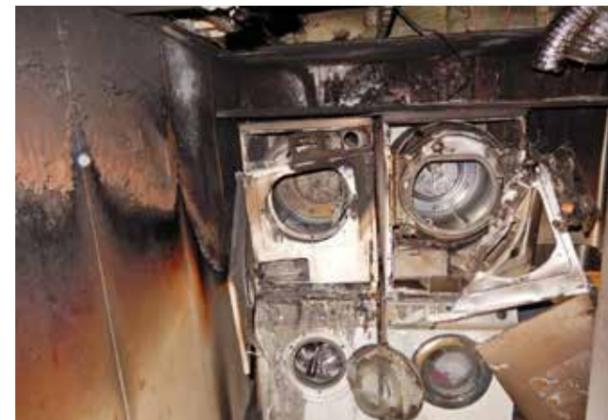
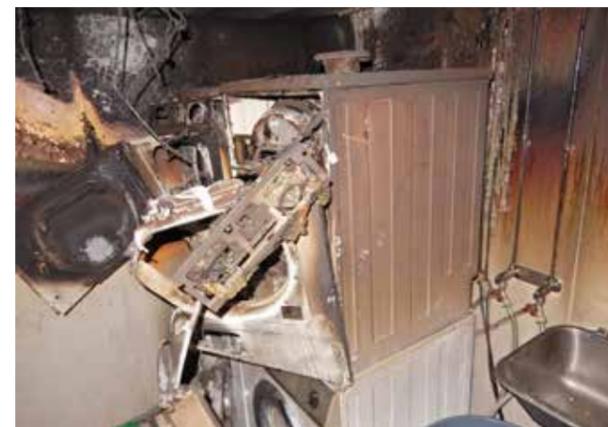
The fire started in one of the tumble driers; the heat became so intense that the paint on the bulkhead caught fire. In addition, part of the drawer ignited.

Pictured: The intensity of the heat can be seen by the amount of damage to the walls

- Regular checks to be made of air filters for tumble driers
- Ventilation system to be verified as working properly to avoid high humidity / temperature in the room, which could cause a short circuit
- Evaluate if equipment is suitable for the laundry, e.g. should tumble driers be of the type that have a water accumulation container with high-level cut-off function, or is the existing water drainage / ventilation system considered efficient?
- Consider installation of additional temperature sensors / electrical tripping system
- Regular maintenance routines - cleaning of filters, ventilation, as well as general check of units' safety functions
- General Safety Assessment, taking into account the risk of fires in vessel's laundry rooms which are usually located adjacent or close to living quarters.
