NORWEGIAN HULL CLUB

Casualty Information

No. 105 - April 2020

Damage to 4-stroke Engine Main Components

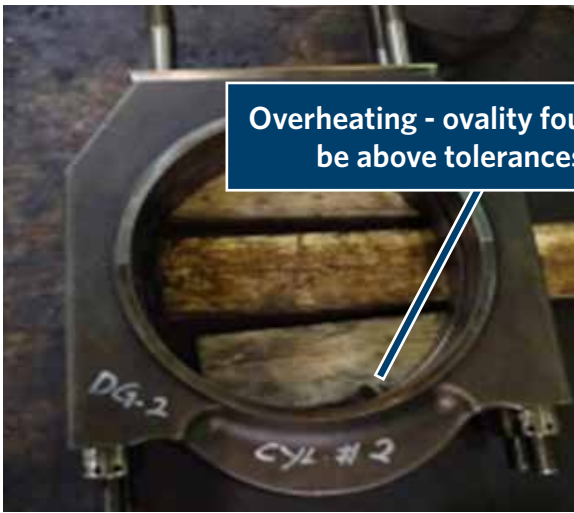
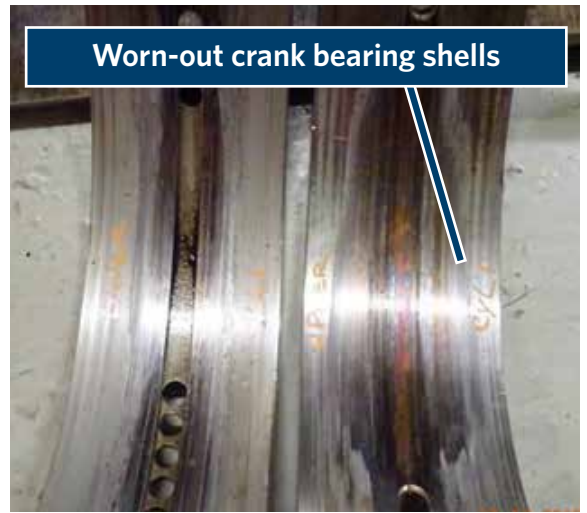
Above: Connecting Rod Bearing Housing

We have recorded cases of sudden damage to crankpin bearings; this has resulted in the overheating of the crankpin followed by the piston becoming stuck fast in the cylinder liner and breaking the connection rod. The pistons and connecting rods have then been thrown out through the engine block and been found lying on the floor beside the engine.

- Regarding routine overhaul, ensure that the connection rod bolts are tightened to the correct torque.
- Note that the connecting rod bolts normally have a maximum lifetime, hence bolts have to be replaced according to the engine maker's guidelines.
- Check that tools are in good condition (torque spanners and hydraulic jacks and pumps).
- Measure the connection rod bearing housing ovality and check the general condition.
- Tolerances and measuring method in accordance to Engine Maker's instruction manual.
- Check the general condition of crank pins and surface roughness. If possible, measure the crankpin (measurement method and condition checks as per engine maker's instructions).
