NORWEGIAN HULL CLUB

Casualty Information

No. 110 - December 2020

Bridge and Accommodation fires during lay-up

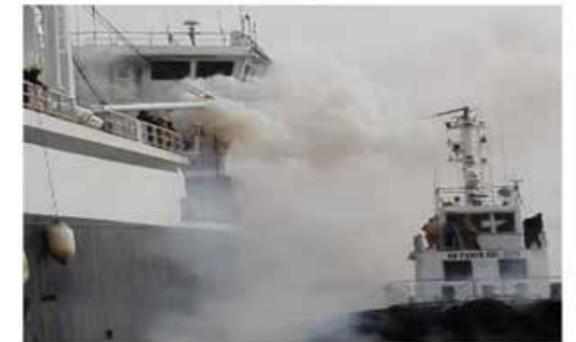
A port fire patrol boat at work

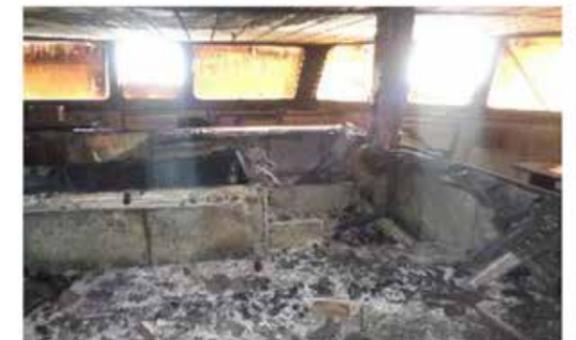
Damage to the Bridge, Accommodation, Deck Houses, Freezer Rooms.

The fire started in the vessel's gymnasium; however, the cause of fire could not be concluded.

Damage on the Navigation Bridge

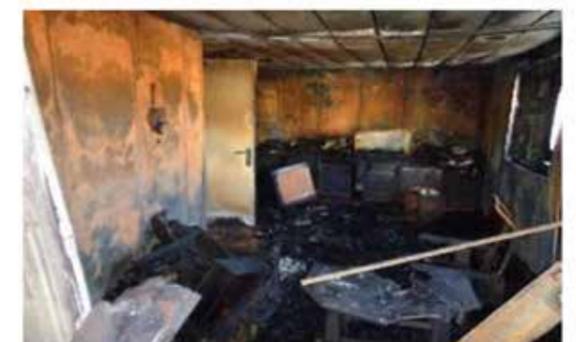
Damage to the Master's Cabin and Office

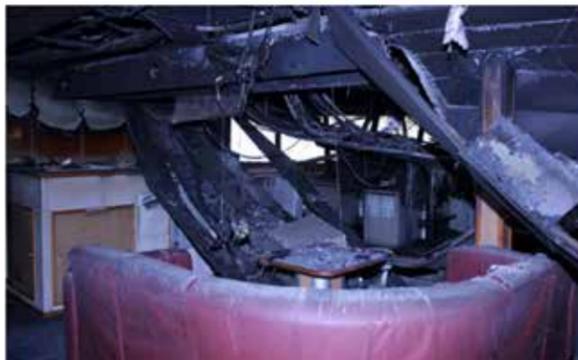
Damage to Bridge and partially to Accommodation. The fire started within the wheelhouse ceiling void space in an electrical connection box with a circuit board installed on a plywood board inside of the ceiling.

Fire occurred in the Bridge ceiling/void

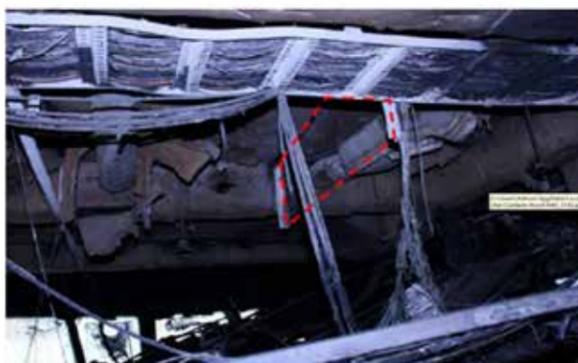
Indicated position of plywood board on which electrical equipment was installed

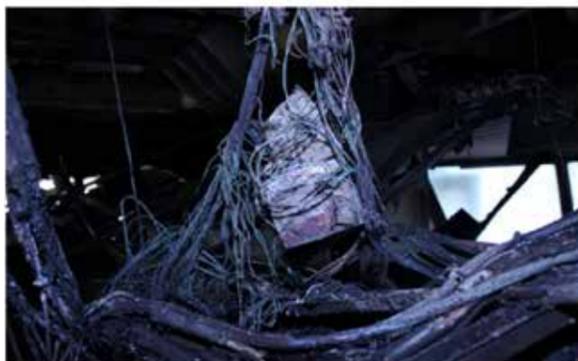
Damaged wiring and circuit board which was fitted to the plywood board.

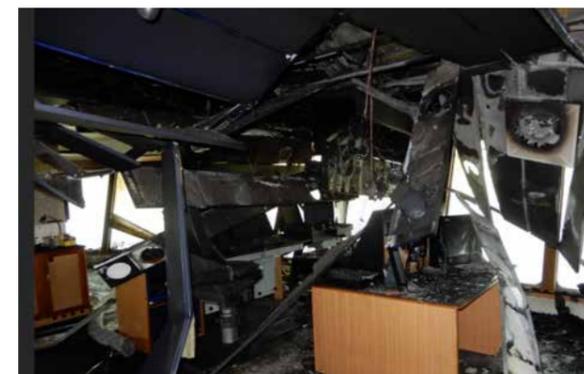
Fire started in the ceiling and its panels fell down

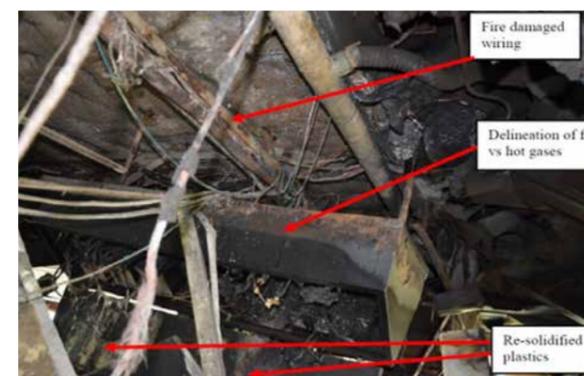
The fire started in the ceiling space on the aft port quarter of the Bridge. There was some wiring in the area, although much of it appears not to have been energized at the time. The cause of the fire was most likely an electrical fault in a wiring connection, or on a faulty PCB. A small resistive heating or tracking fault on a PCB is one possible cause of the fire.

Where the fire started

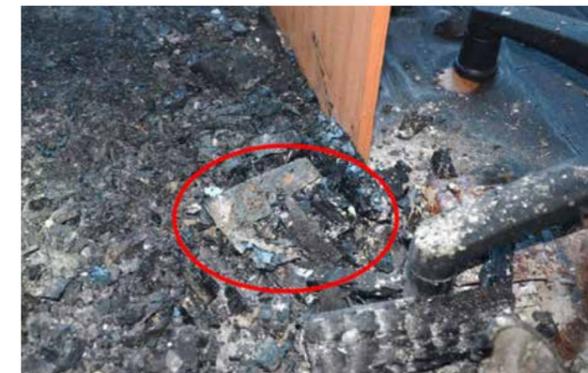
The PCB (circuit board) lying amongst debris on the floor
