## **Casualty Information**

No. 114 - February 2022

Damage to controllable pitch propeller systems

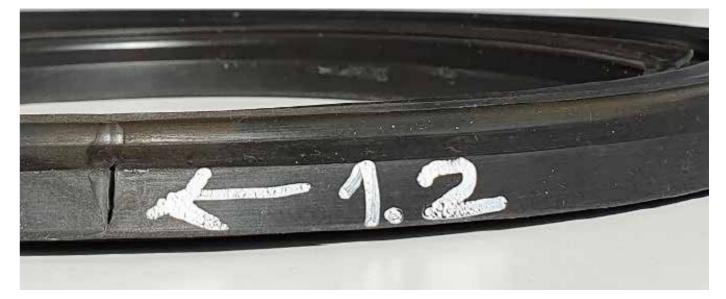
Propeller blade seals - poor ring joint bonding/seal twisted

- 1. That filters, header tanks and power-pack tanks are regularly checked for impurities.
- 2. That representative oil samples are sent to a laboratory for analysis shortly after a vessel has been put into service following delivery. This to help identify any degradation in oil quality, as well as possible wear from the propeller system internal components at an early stage.
- 3. The building or repair yard, in cooperation with the system maker, prepares procedures that follow industry standards related to the flushing of the oil systems, prior to delivery. Proper testing of the system before and in connection with a sea trial should be carried out.
- 4. Propeller system maker's procedures, recommendations and guidelines to be followed.

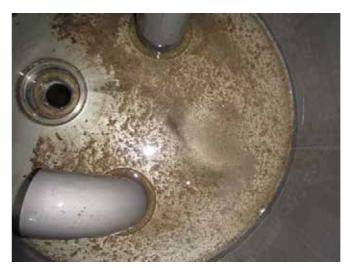
Debris in the bottom of an oil gravity tank

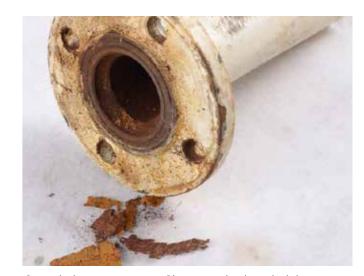
Corroded pipe, not up to Class standard, with debris

connections delivered by the yard are class approved for use in hydraulic systems.

In addition, where hydraulic pipes are to be connected with welded sleeve couplings, class-approved standards must be followed. Even tiny pieces of welding slag and / or spatters that pass through a filter can potentially cause severe damage to a propeller plant's internal seals and movable parts.

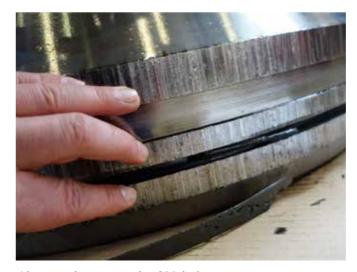
Abrasive damage to the CPP hub piston

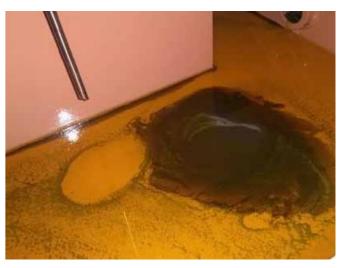
Sediments and impurities in power pack oil tank

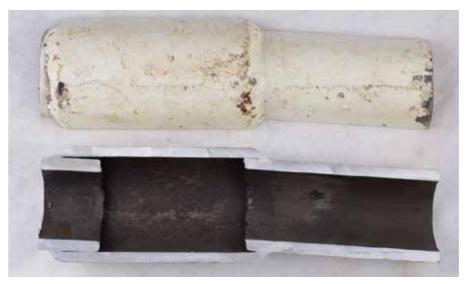
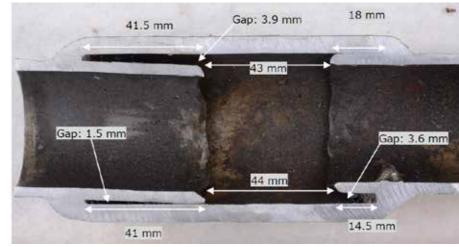
The fit-up and alignment of the pipes to be done as per normal practice to avoid "gaps and pockets" for debris to accumulate
