NORWEGIAN HULL CLUB

# Casualty Information

No. 111 - April 2021

**Reducing risks related to the  
operation of ship cranes**

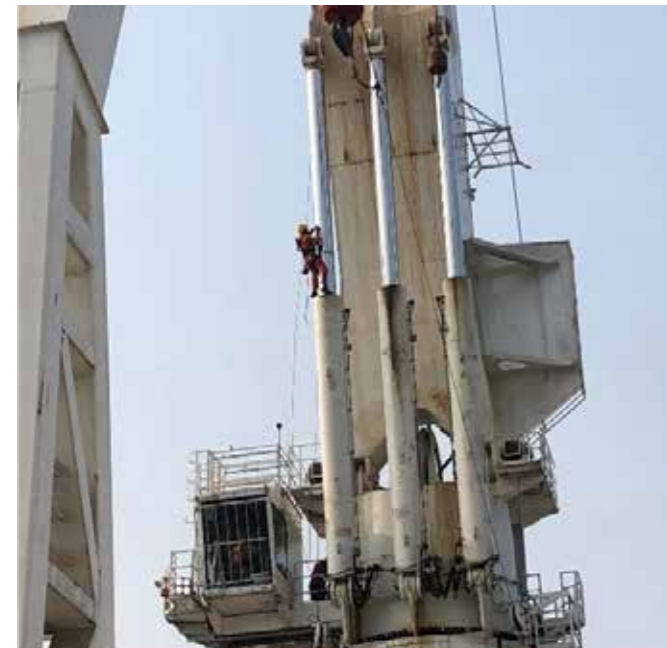
*Damage to hydraulic cylinders due to contact with containers while loading / unloading*

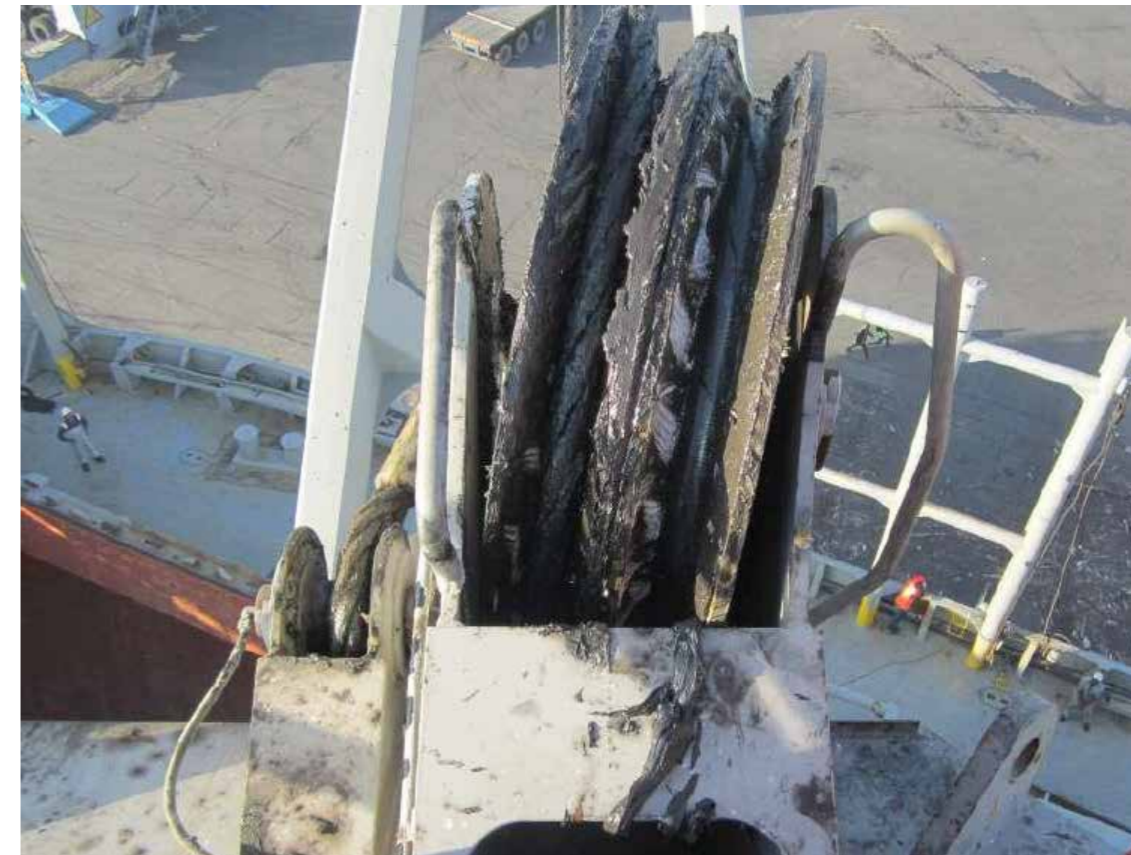
*This image shows a wire sheave which has been damaged*

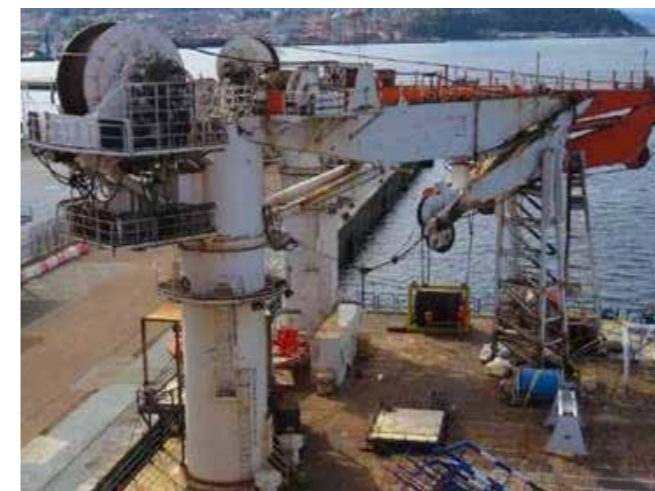
*Damage to the main winch of an offshore crane*

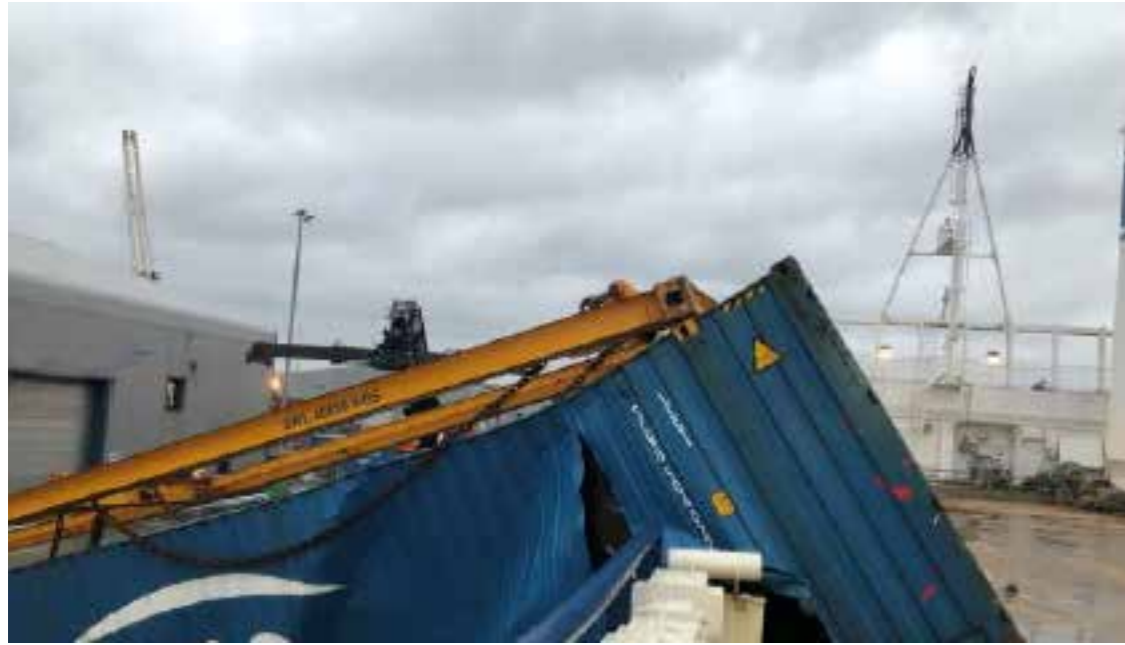
*A container has been ripped open following wires breaking; the cargo inside was damaged*

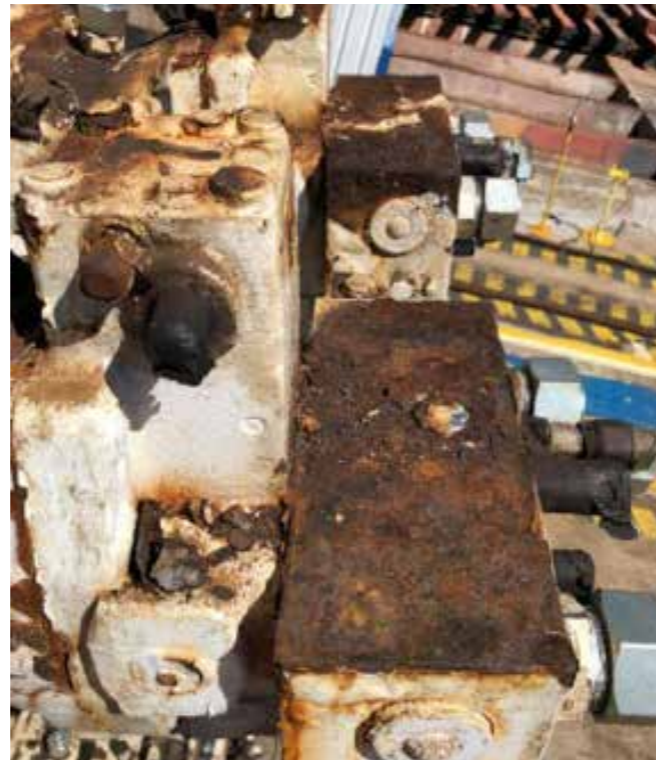
*The effects of poor maintenance on hydraulic components*

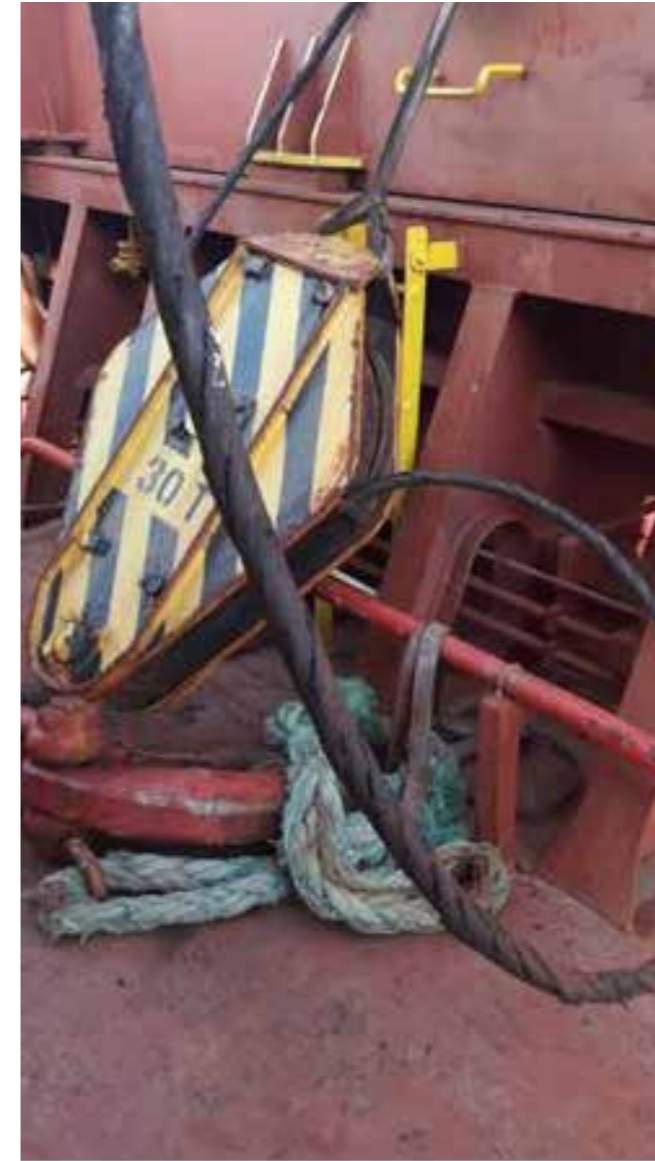
*A cable in poor condition*

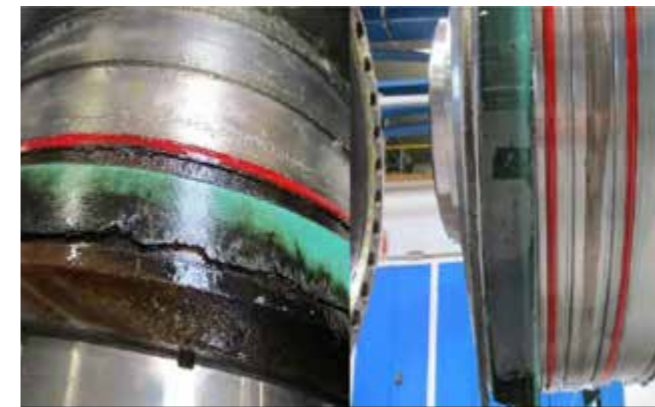
*'Dieseling effect' visible on hydraulic cylinders*
