NORWEGIAN HULL CLUB

Casualty Information

No. 99 – November 2018

Norwegian Hull Club wishes to emphasize increased safety onboard with a focus on **welfare, the environment, assets** and the distribution of **useful experience**. In this letter, we focus on **the importance of proper Box Cooler maintenance**.

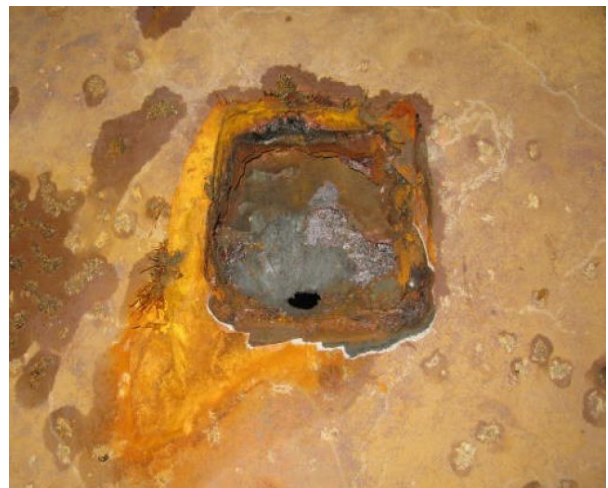
Norwegian Hull Club has seen corrosion damage arising from BCs when the units have most likely not been cleaned and/or painted properly following a vessel's first Special Survey (SPS). The BC compartment itself consists of various materials, including aluminium-brass or copper-nickel in the box cooler tubes, aluminium or zinc anodes, stainless steel used in the BC frame, copper rods in the Impressed Cathodic Anti-Fouling (ICAF) system and the steel of the ship's hull. If these materials are not isolated from each other, this can cause galvanic corrosion.

Levels of galvanic corrosion depend on several factors such as the degree of damage suffered

Example of the effects of galvanic corrosion

by the coating on the BC's tubes (aluminium-brass tubes are coated), the amount and quality of sacrificial anodes, paint type with its thickness and quality and the salt content and temperature of the water. ICAF systems should be closely monitored as they can be prone to loose wires and failing copper anodes. Copper rods **MUST** be isolated to prevent corrosion to the hull.

1. Maintaining BCs according to the manufacturer's instructions, in all aspects (maintenance, painting, sacrificial anodes, ICAF system);
2. Ensuring that specific Scope of Work for maintenance of BCs is stipulated in the dry-docking specification submitted to shipyards;
3. Ensuring qualified supervision of all BC work carried out during dry-docking;
4. Sharing your understanding and experience of the complexity of BCs with your colleagues.
