NORWEGIAN HULL CLUB

Casualty Information

No. 105 - April 2020

Damage to 4-stroke Engine Main Components

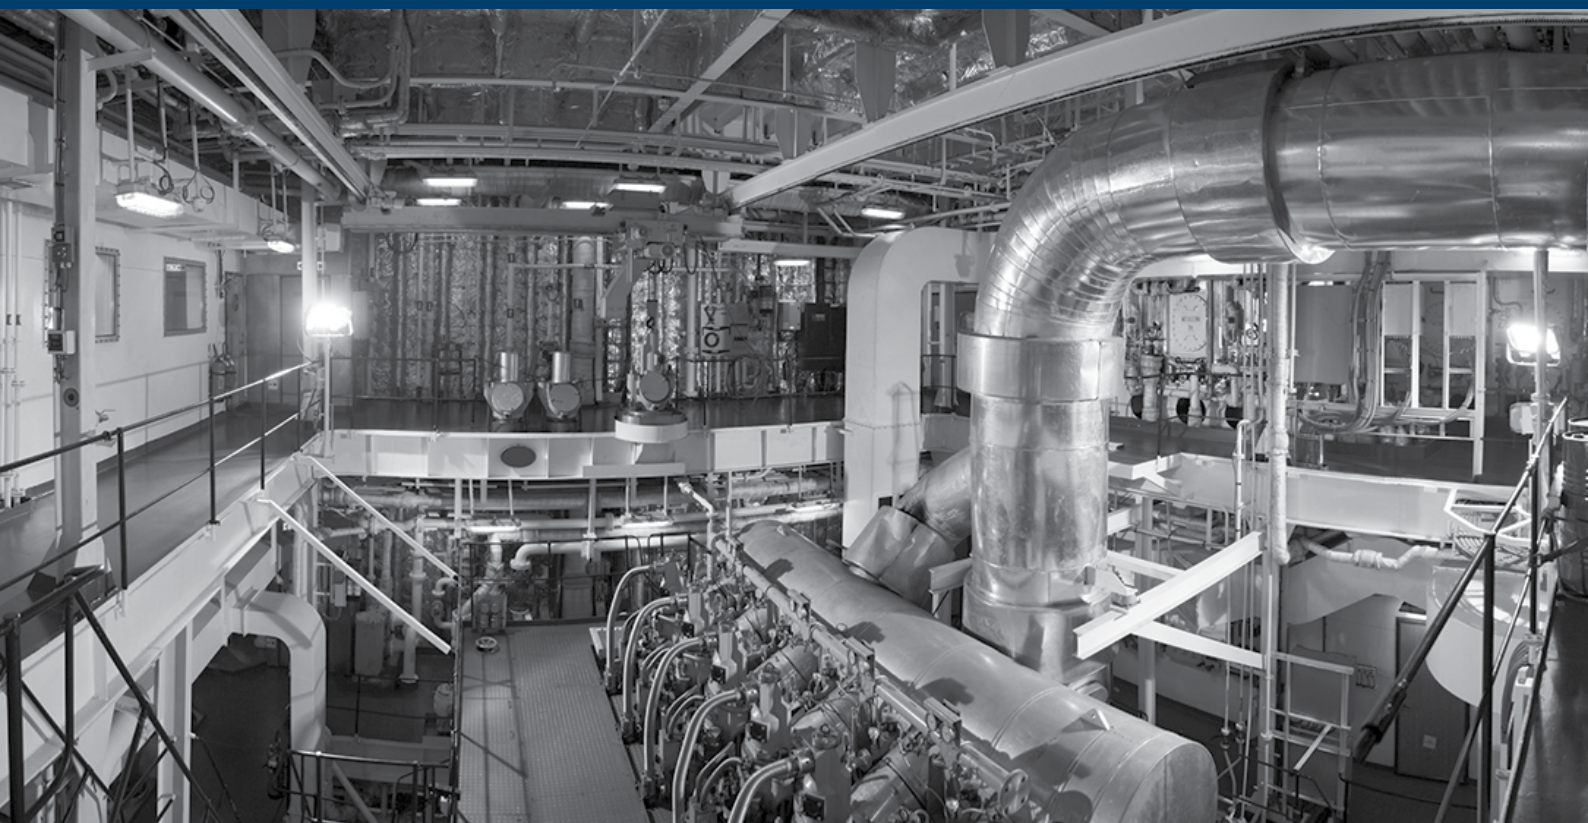
We have recorded cases of sudden damage to crankpin bearings; this has resulted in the overheating of the crankpin followed by the piston becoming stuck fast in the cylinder liner and breaking the connection rod. The pistons and connecting rods have then been thrown out through the engine block and been found lying on the floor beside the engine.

In addition to damage to the engine, in the most serious cases, lubricating oil has leaked out from the damaged engine block and spread onto hot surfaces,

resulting in fires and consequently severe damage to equipment in the engine room.
