NORWEGIAN HULL CLUB

CASUALTY INFORMATION NO. 42 - MARCH 2004

“NEAR COLLISION” AND GROUNDING.

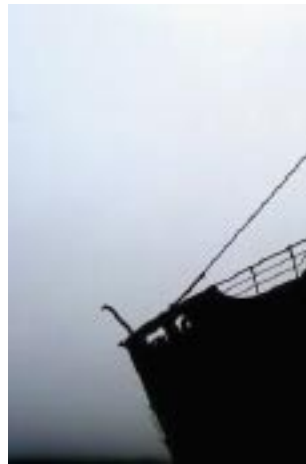
The basic mistake here seems to be B's failure to note A's three red lanterns and/or not appreciating the implications in the actual waters. B also did not pay attention to its radar, and clearly violated Rules no. 5 and 7, since A's course change

was not detected even if it was apparent on the radar screen. B's crossing of the narrow channel was in itself a violation of the Rules. One consideration is, of course, how to evaluate B's late starboard turn and crossing A's bow at such a close range. This manoeuvre was probably an “automatic” reaction to bring the vessel over on the traditionally correct side of

the channel (Rule 14). However, here B violated Rule no 15.

- It is good practice to review and discuss the COLREG Rules and possible implications from time to time.
- Remember that you are required to operate your radar with proficiency.
- Study the charts of the area before you get there, and think through “What-if” scenarios.
- Never deviate from normal sailing routes without very careful consideration of possible consequences.
- Hone your Bridge Resource Management organisation, and make use of it whenever something out of the ordinary happens.

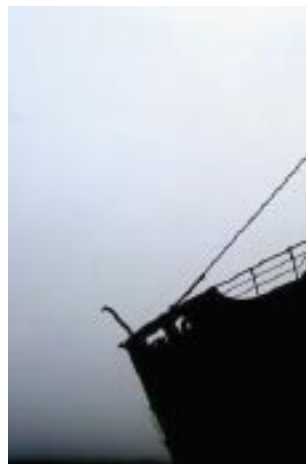
Den grunnleggende feil her synes å være B's manglende oppfattelse av A's tre røde lanterner samt betydningen av disse i dette farvannet. B fulgte heller ikke med på radaren, og brøt klart Sjøveiseglene 5 og 7, siden A's kursendring ikke

ble oppdaget selv om dette fremgikk av radarskjermen. B's kryssing av den trange kanalen var i seg selv et brudd med Reglene.

En vurdering er selvsagt hvordan man skal evaluere B's sene styrbord tårn og kryssing av A's baug på så kort avstand. Denne manøveren var sannsynligvis en «automatisk» reaksjon for å bringe skipet over på den

tradisjonelt riktige side av kanalen (Regel 14). Imidlertid brøt B her Regel 15. Det er også slik at forfatterne av Sjøveiseglene forsto at det ikke er mulig å dekke alle mulige situasjoner i ett sett med regler. Derfor ble Regel 2b, Ansvar, føyd til, hvor sjøfareren direkte blir beordret til å være oppmerksom og bruke fornuft i de tilfeller hvor det kan være farlig å følge Reglene bokstavelig. Nærværende tilfelle anses å være et godt eksempel på når man må vurdere Regel 2b: «Ved tolking av disse reglene og når de følges skal det tas nøye hensyn til alle farer for navigeringen og for sammenstøt, like ens til alle særlige omstendigheter, herunder begrensninger av vedkommende fartøys manøvreringsmuligheter, som måtte gjøre det nødvendig å avvike fra disse reglene for å unngå øyeblikkelig fare.»

- Det er god praksis av og til å gjennomgå og diskutere Sjøveisreglene med forskjellige applikasjoner.
- Husk at det kreves at du kan operere din radar profesjonelt.
- Studer kartene over området før du kommer dit, og tenk gjennom «Hva-om» scenarier.
- Fravik aldri normal seilingsled uten meget nøye vurdering av mulige konsekvenser.
- Tenk «Ship Resource Management».
